805 MHz cavity refurbishment

NFMCC collaboration meeting

Bob Rimmer

JLab

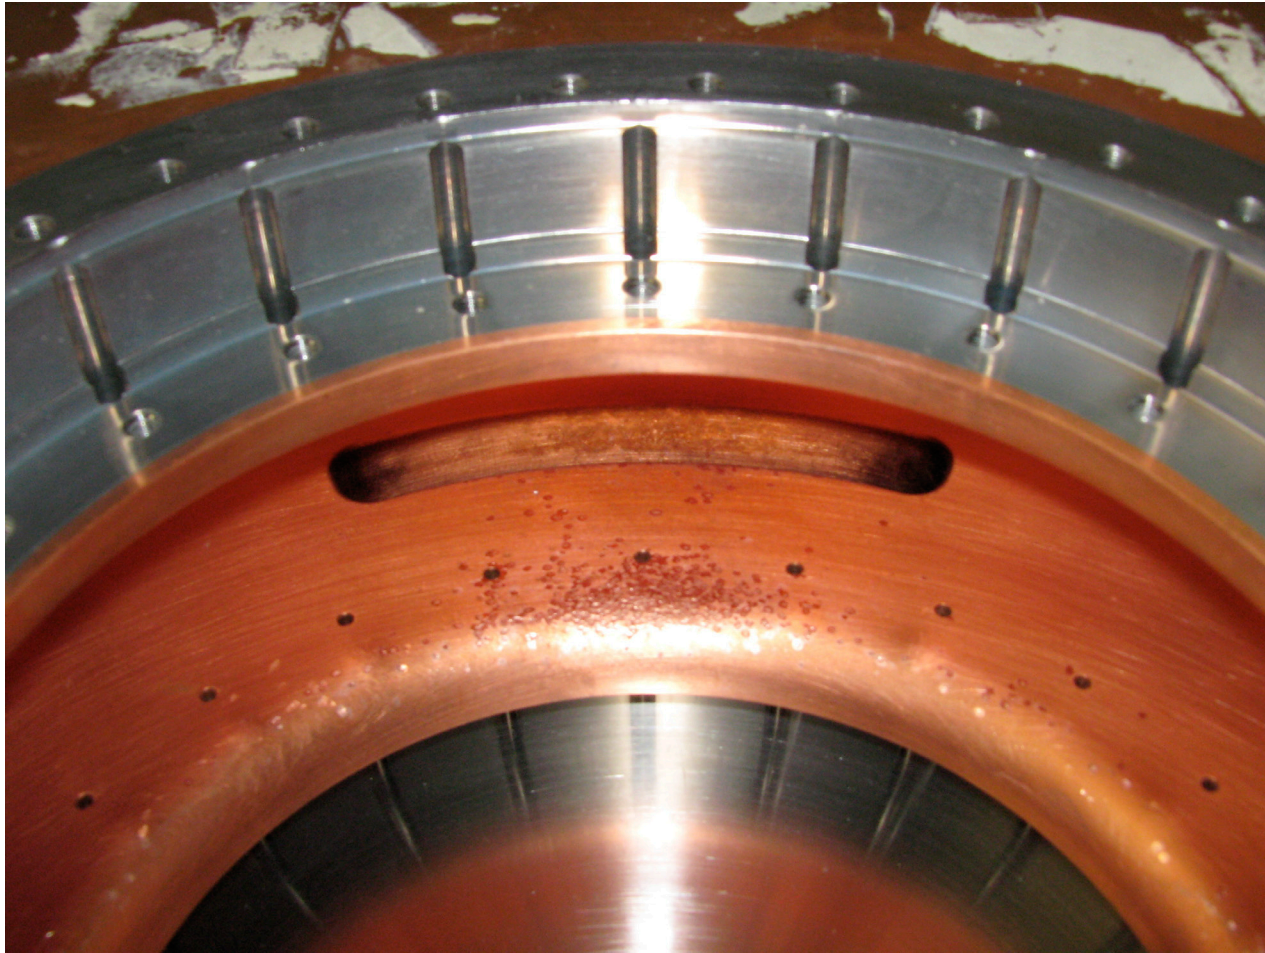
- Cavity was heavily arc damaged after many runs at high magnetic field
- Heavy pitting on button holder, irises (with slight “dipole” asymmetry)
- Further inspection revealed significant damage in the coupler region
- May explain why all button tests followed similar processing curve with magnetic field

805 Cavity “before”

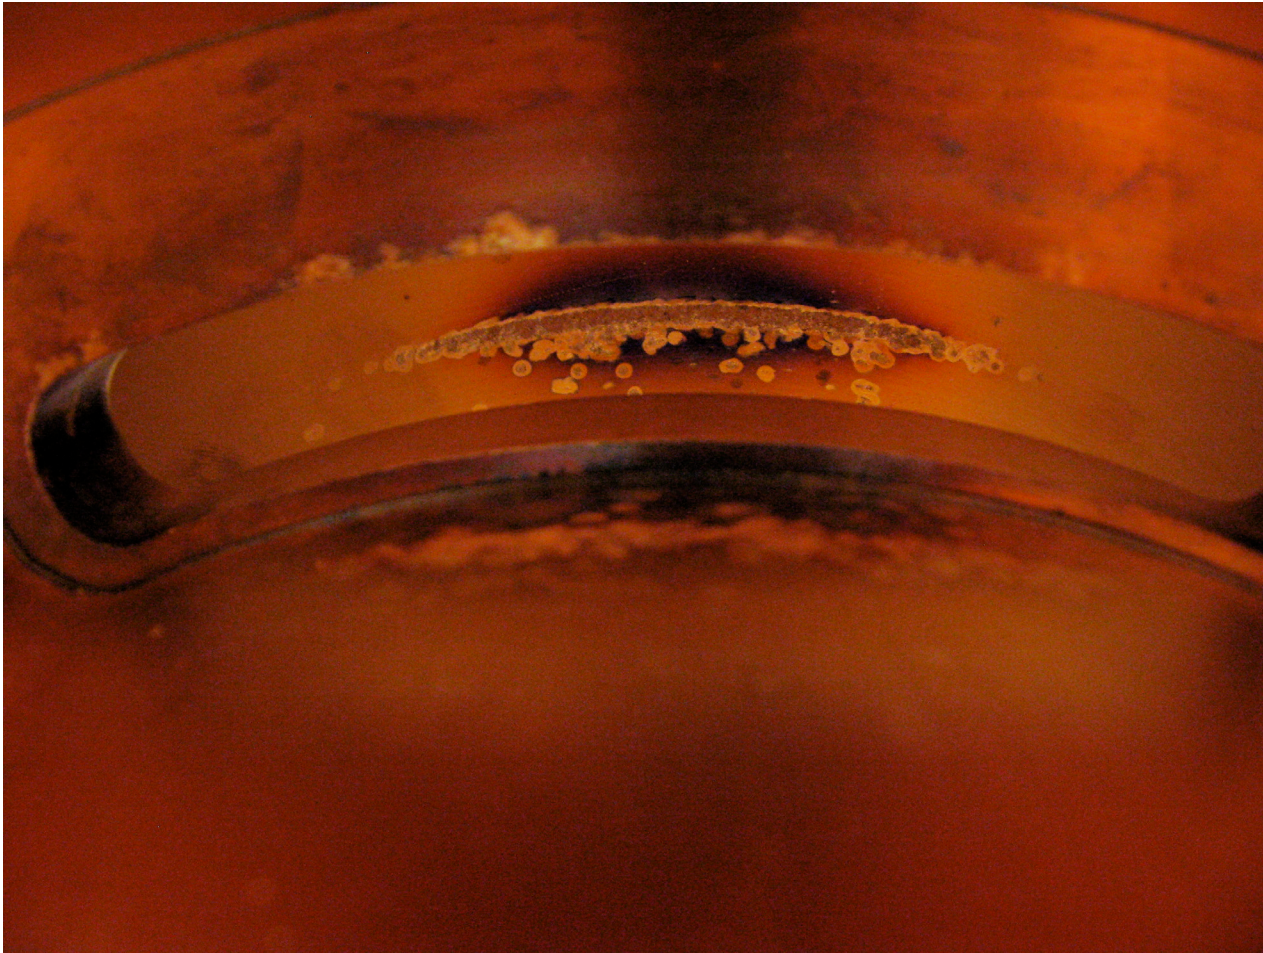
Coupler region damage

- Polish out all visible iris damage
- Polish out arc marks in coupler region
- Polish out arc marks in coupler extension
- Cut inner and outer blend radii on coupler
- Ultrasonic clean and DI water rinse (HPR)
- Clean room assembly (to be done)
 - Cu and Be windows available
 - Button holder needs to be re-worked or re-made
- No electropolishing

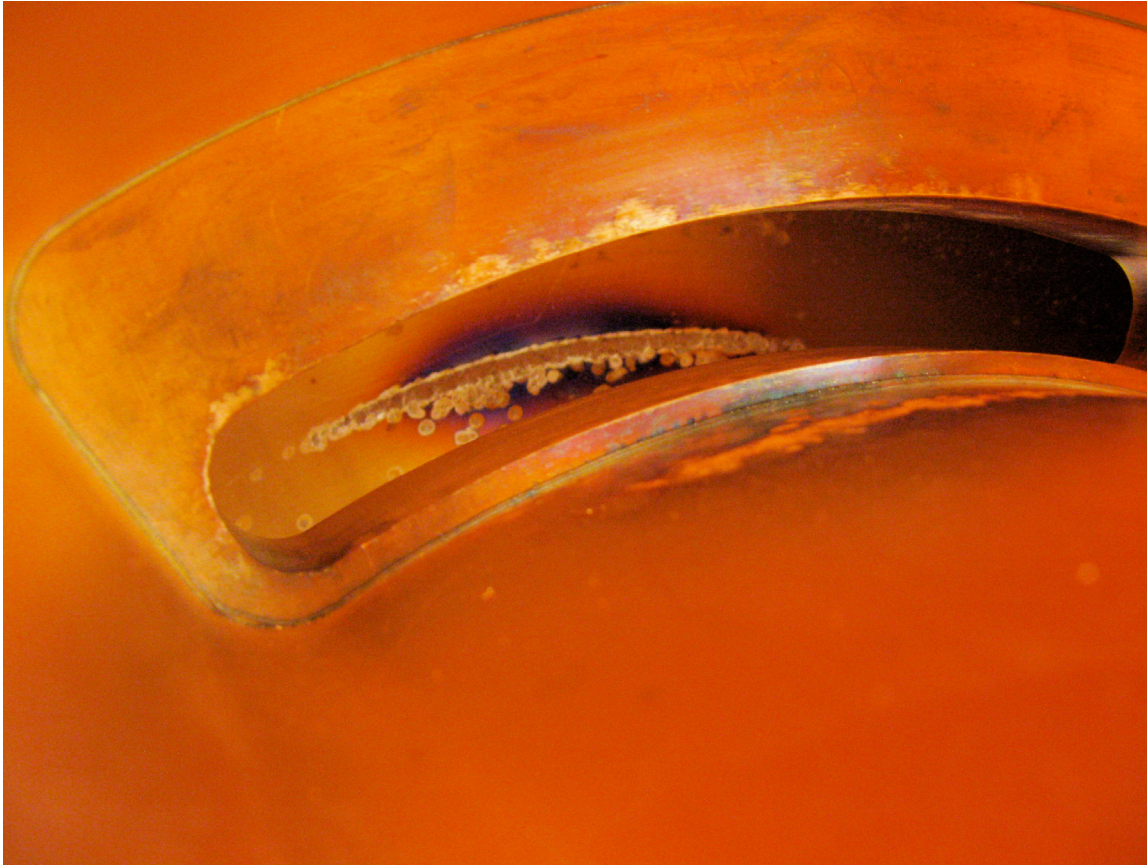
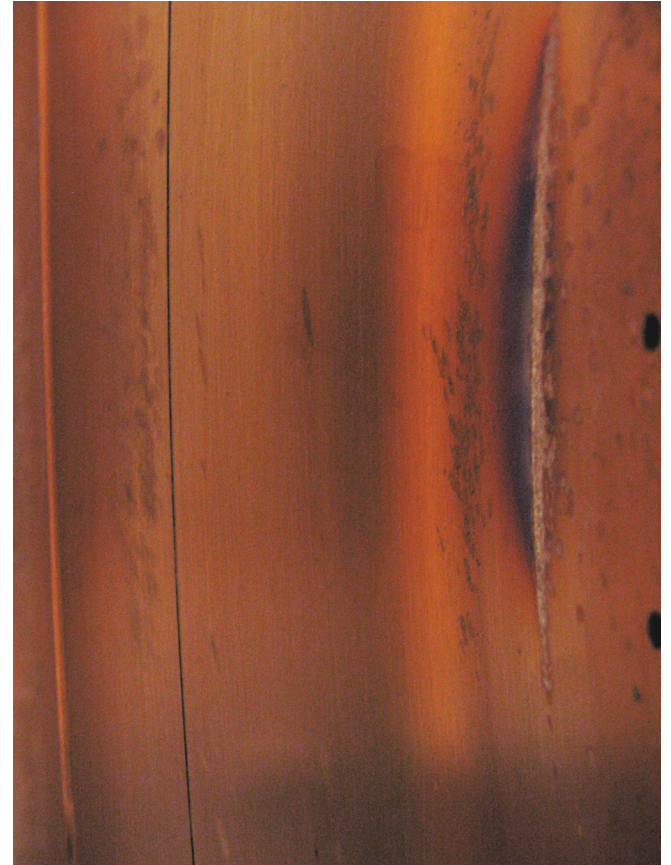
Coupler region damage

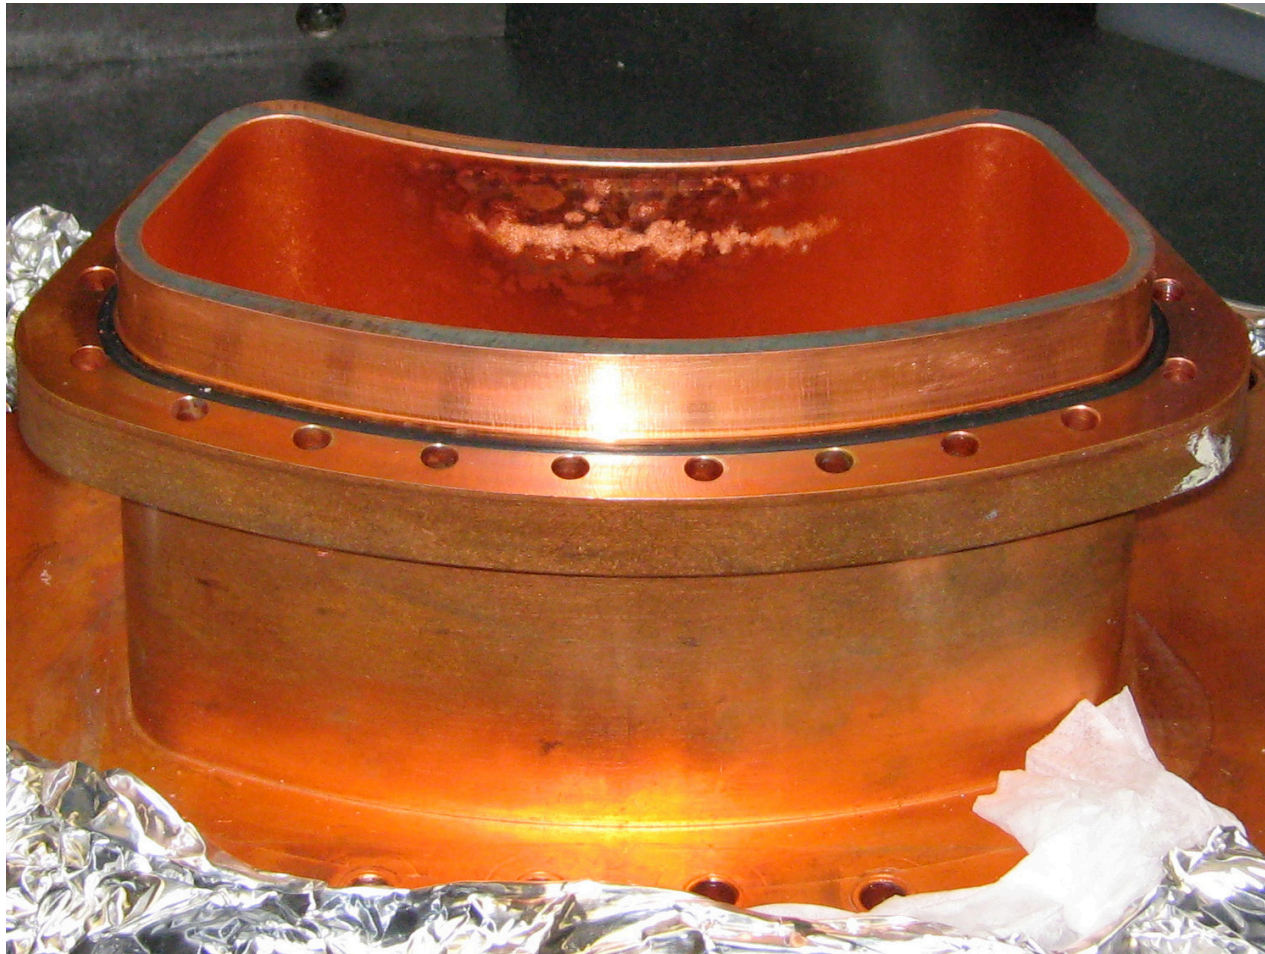
Coupler extension damage
