MTA RF work

A. Jansson

Outline

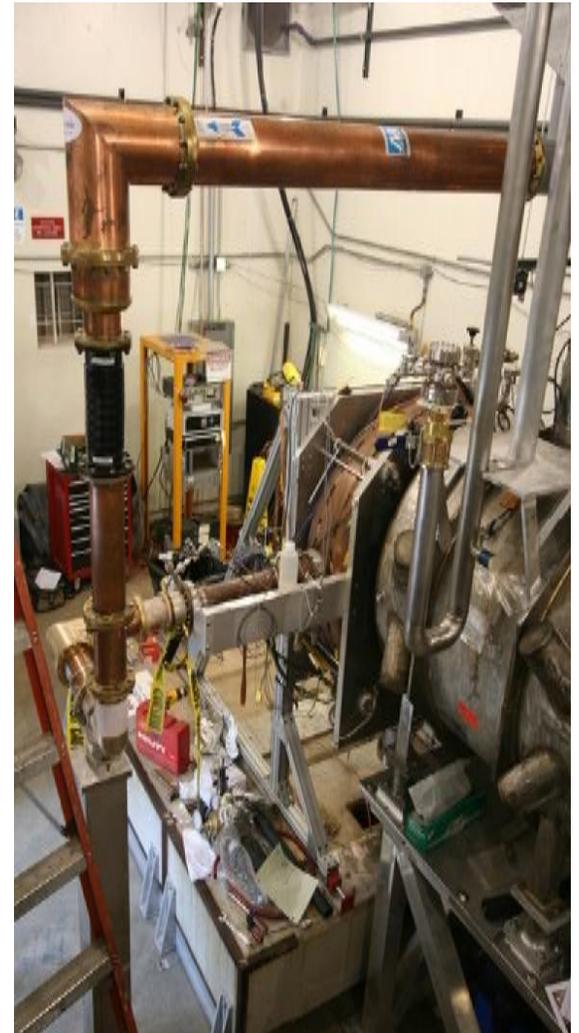
- Hall mechanical and electrical
 - 201 MHz cavity on new platform, magnet and valve box on new stands
 - New cables installed, new detector stands to be built Dec
 - Clean room raised, fans/lighting to be upgraded next week
 - Manlift replaced, mobile crane, lifting fixtures to be delivered Dec

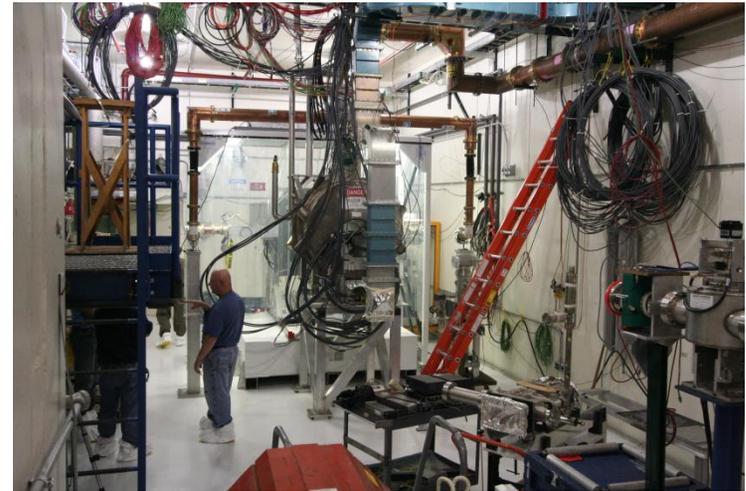
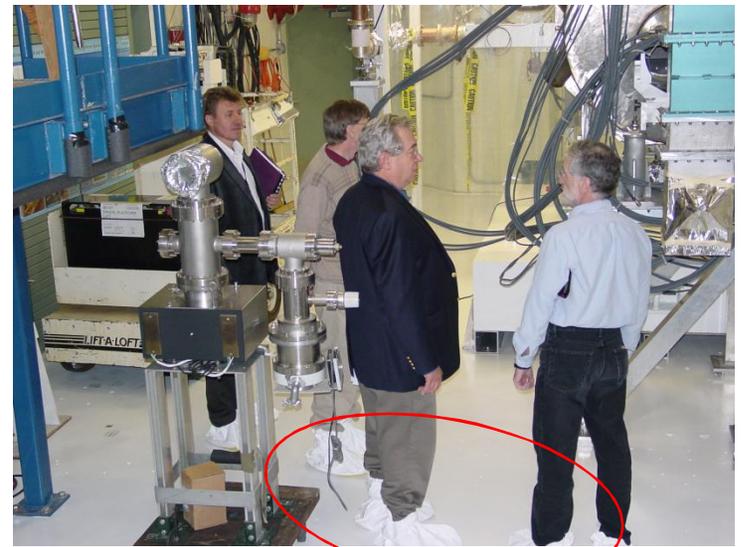
- Upgrade clean room to around class-100 for RF cavity inspection.
 - Everything in hall wiped down, hall and entryway floors sealed
 - New rules (no drilling, cutting; wipe down new equipment; wear shoe covers)
 - Upstairs entrance reconfigured with new door, cabinet to be installed for shoe/shoecover storage
 - Clean room to be cleaned next week
 - New instrumentation to monitor particle counts, temperature, humidity in clean room

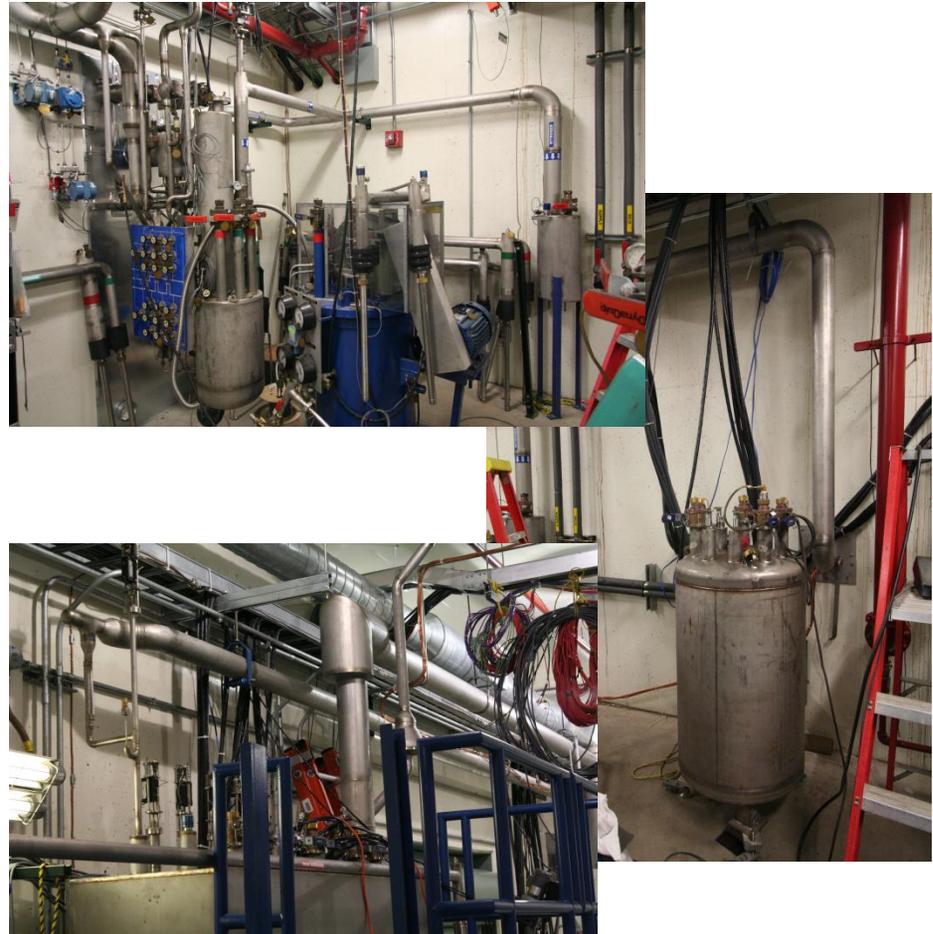
- Move from Dewar operation to cryo plant
 - Valve box in hall and transfer line installed
 - Plumbing, controls, instrumentation to be finished this week
 - Commissioning, magnet cool-down expected Dec/Jan

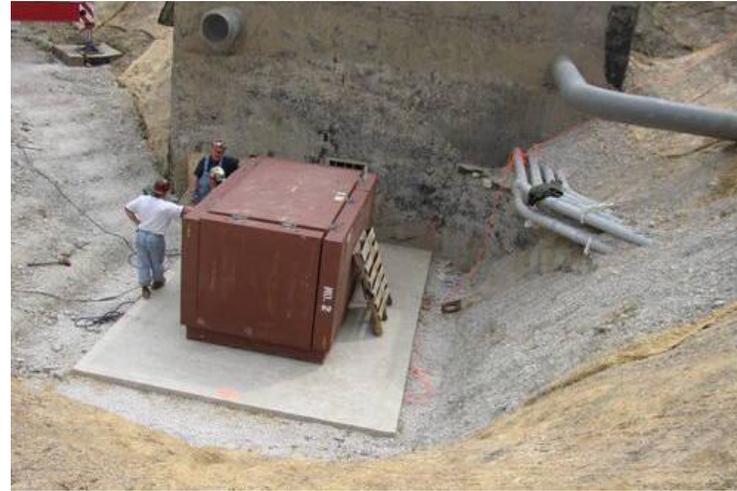
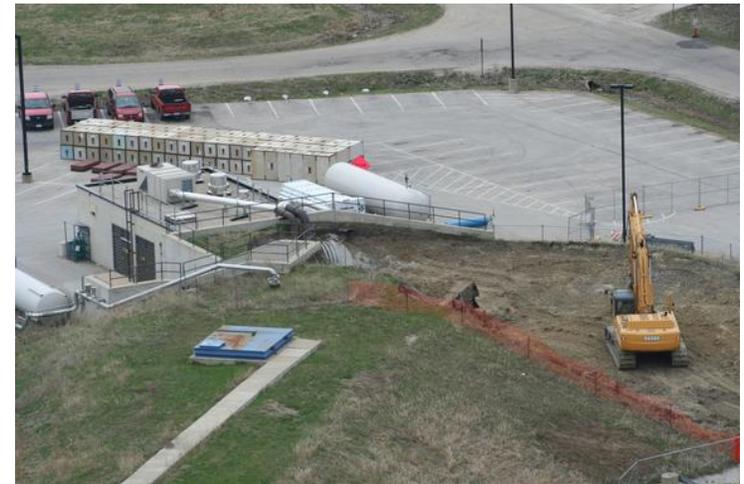
- Beam commissioned to 1st stop, beam absorber installed
- Rate limiter built, controls integration shake-down Dec
- Waveguides rerouted, shielding replaced in pit and hatch, small amount to be installed in refrigerator room (and possibly hall)
- Radiation assessment to be submitted to DOE Dec/Jan
 - Rad Safety have first draft
- Commissioning to hall when approved (Spring 2010)

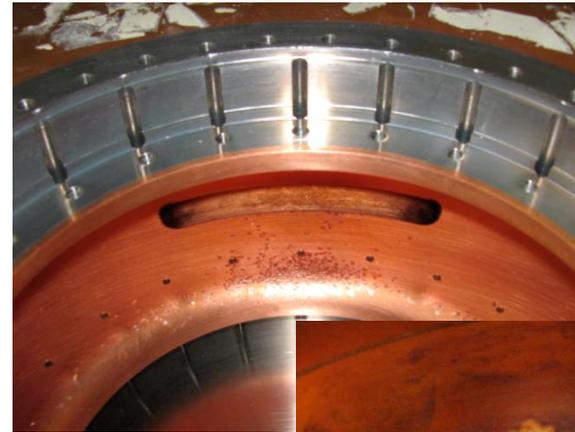
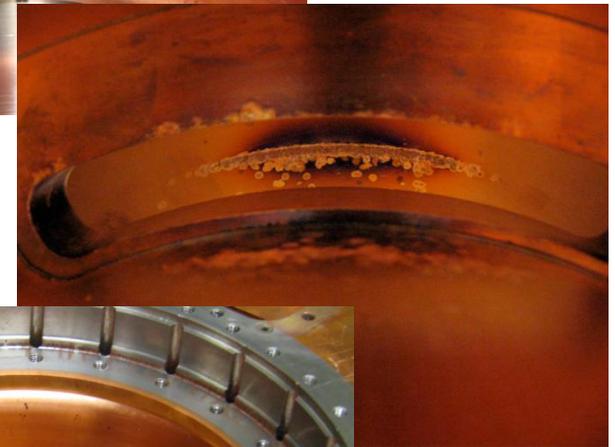
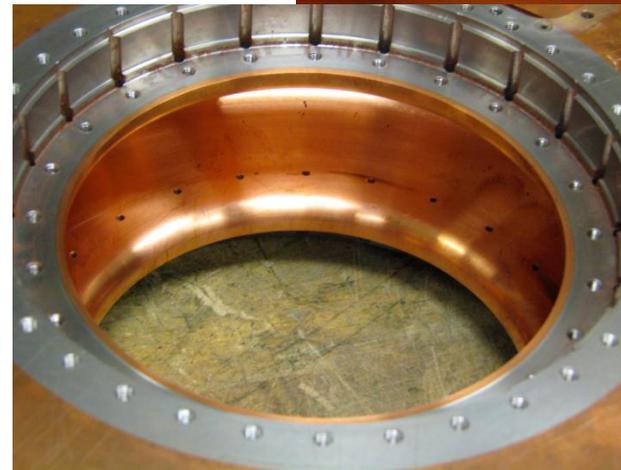
- Goal is to refurbish the cavity, ensure that breakdown is confined to button surfaces and redo button studies
- Cavity repaired at JLab
 - Interior surface polished, coupler slot edges rounded
 - but not leak tight after assembly
- New tin seals (vacuum) built at LBNL (sent to JLab this week)
- Button hardware machined at Mississippi
 - 2 new button holders (sent to Jlab this week)
 - 2 new Cu disks (under button holder) to be finished mid-Dec
 - 2 Cu and 2 Be buttons with new design (x 2.25 field enhancement, up from 1.7)
 - Also 2 old style button holders
 - to be paired with unused Cu and possibly other old buttons
 - as well as fresh ones from Cockcroft
- Parts to be TiN coated at Jlab (Jan)
- Final assembly, leak check afterward
- Installation at Fermilab (Jan)
 - Minor changes to vacuum system to accommodate new configuration

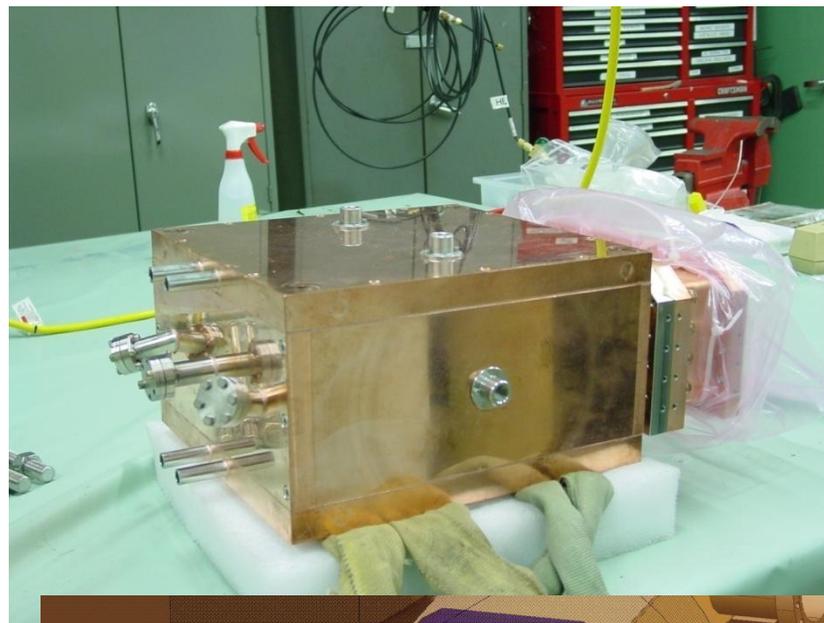
1. The Orthogonal box cavity has been connected to its $\frac{1}{4}$ waveguide coupling section through a Tin seal and successfully vacuum leak checked in the A0 test lab, Figures 1, 2 and 3.

2. After the Holidays, Test WG Power Coupling Section, Figure 4 and 5, will be attached and Network Analyzer measurements of the match, Frequency, and Q_0 made. The frequency with probes has been made and F_0 was found to be within calculated range at 804.978 MHz.

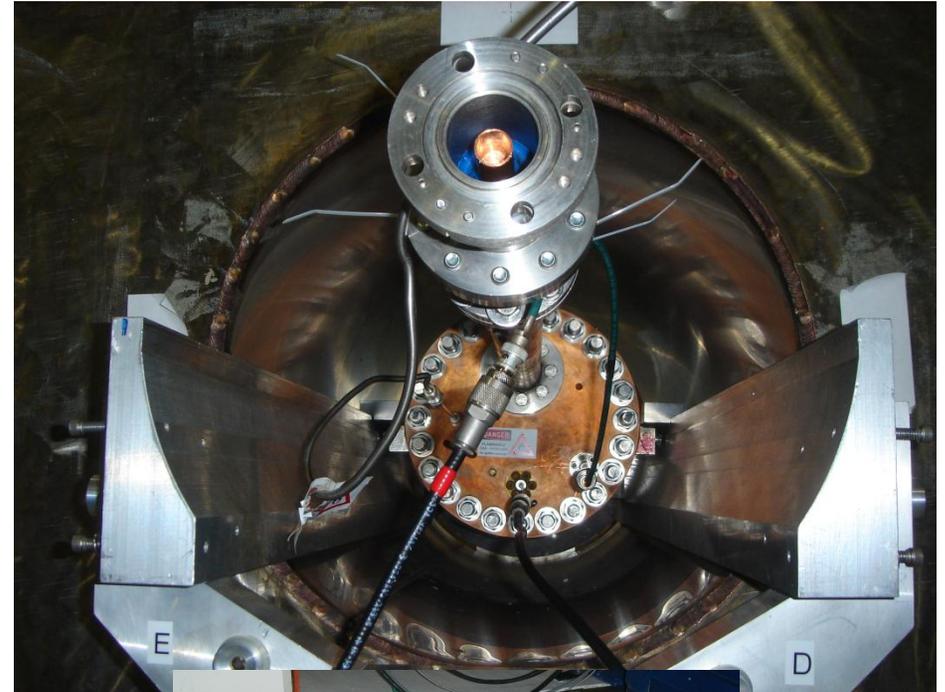
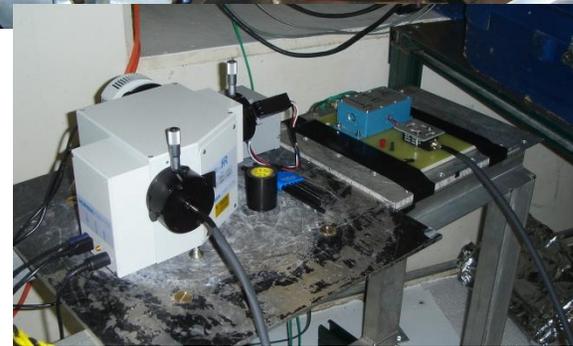
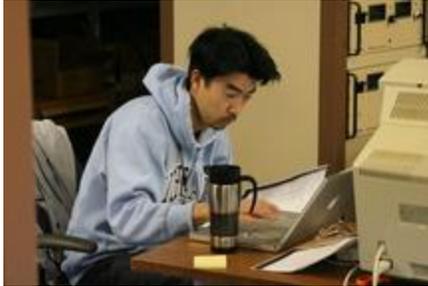
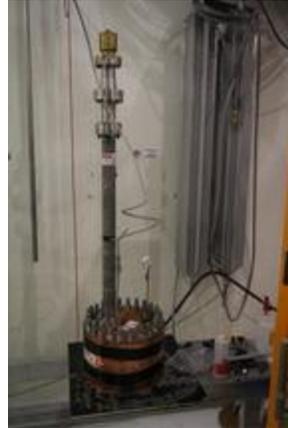
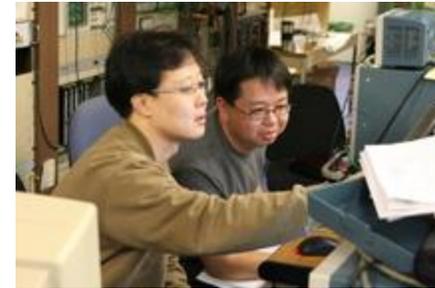
- Cavity modified
 - Added 2nd optical port
 - Added magnetic pick-up
- New optical diagnostics
 - Faster PMT
 - Spectrometer/Monochromometer
- Planning for beam test
 - RF re-routing
 - Design collimator to define beam

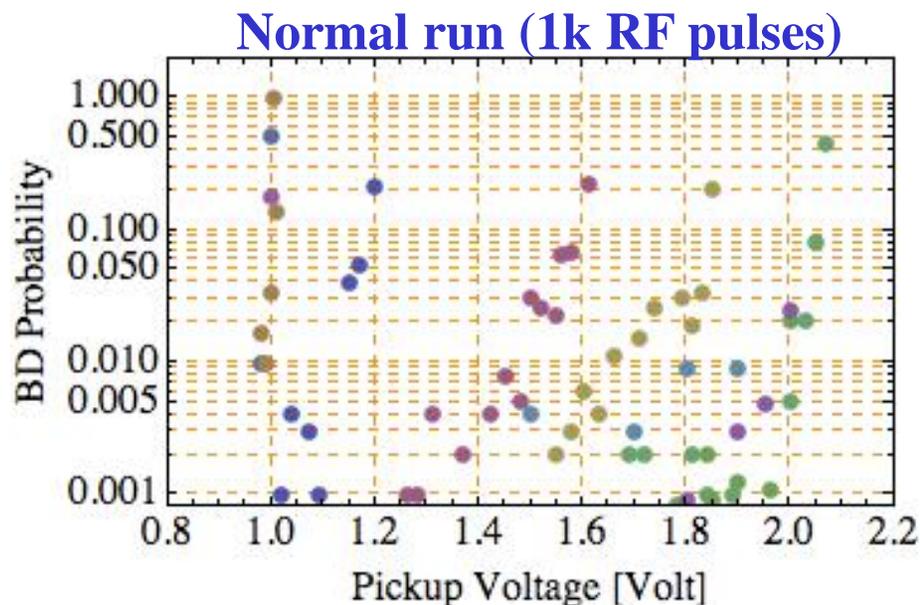
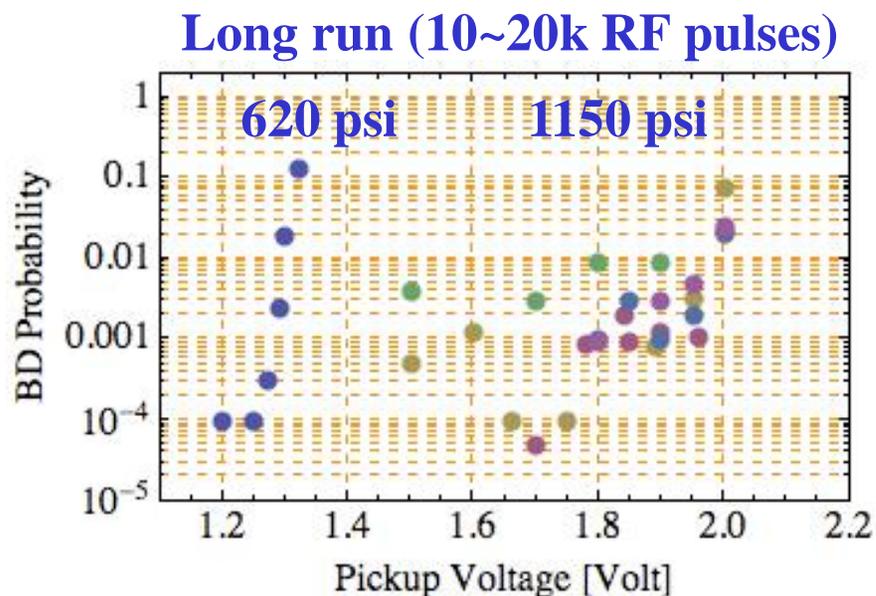
STUDY OF BREAKDOWN PROBABILITY

$$Probability = \frac{N_{BD}}{N_{RF}} \quad \begin{array}{l} N_{BD} : \# \text{ of breakdowns} \\ N : \# \text{ of RF pulses} \end{array}$$

- BD probability curve is very clear shape at low pressure region
- Boundary becomes fuzzy at high pressure region (> ~1000 psi)

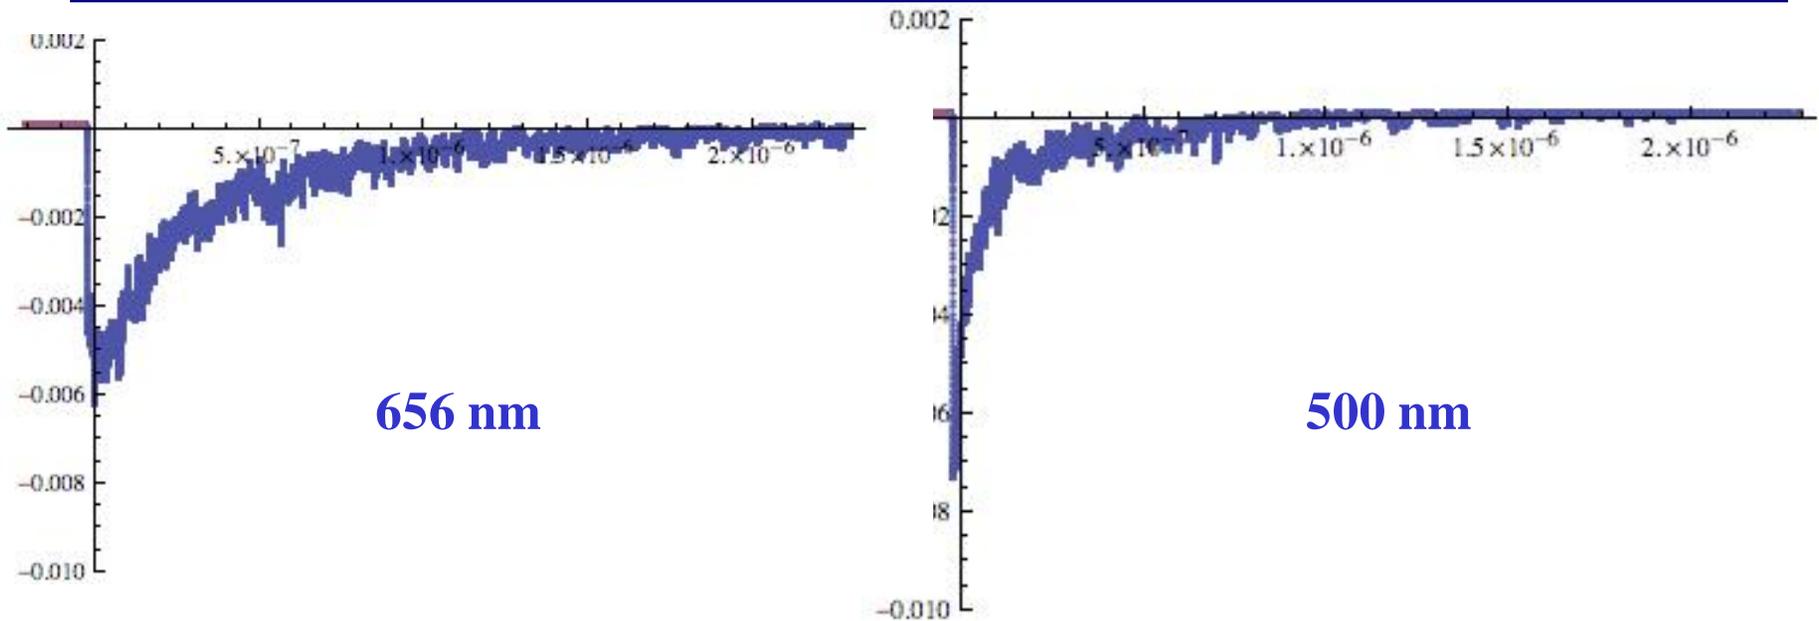
SPECTROSCOPIC STUDY

- **656 nm is near H-alpha line**
- **500 nm is none of any atomic lines**
- **Decay slope in 656 nm spectrum is ~ 500 ns, that is matched to the spontaneous emission lifetime (inverse of Einstein constant)**

- Very successful run!
- Probability of breakdown as a function of voltage mapped out for various gas pressures
- First spectroscopic measurement in HPRF has been done,
 - Hydrogen lines observed
 - Broad band spectra was observed (may be able to extract plasma temperature from this)
- More detailed results will be reported once analysis is complete
