Radiation Effects in a Couple Solid Spallation Target Materials

**S.A. Maloy, W. F. Sommer, M.R. James, T.J. Romero, M.L.
Lopez**

Los Alamos National Laboratory, Los Alamos, NM 87545

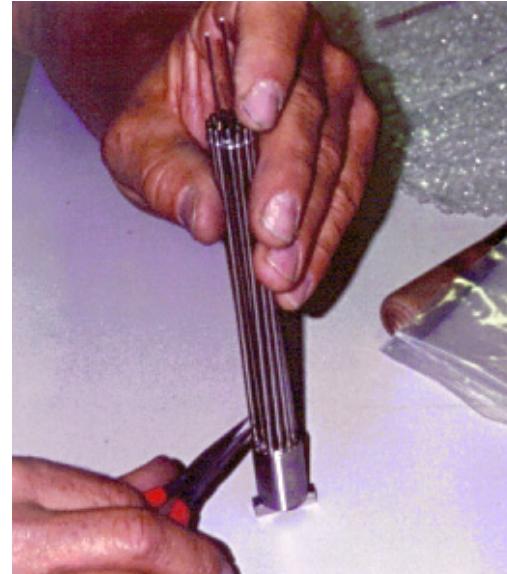
Assembly of Clad Tungsten Rod Bundles

- Rods placed on orifice plate.
- Held in position with removable spacer.
- Frozen in water and spacer removed.
- Attached second orifice plate.
- E-beam welded orifice plates to outer tubes.

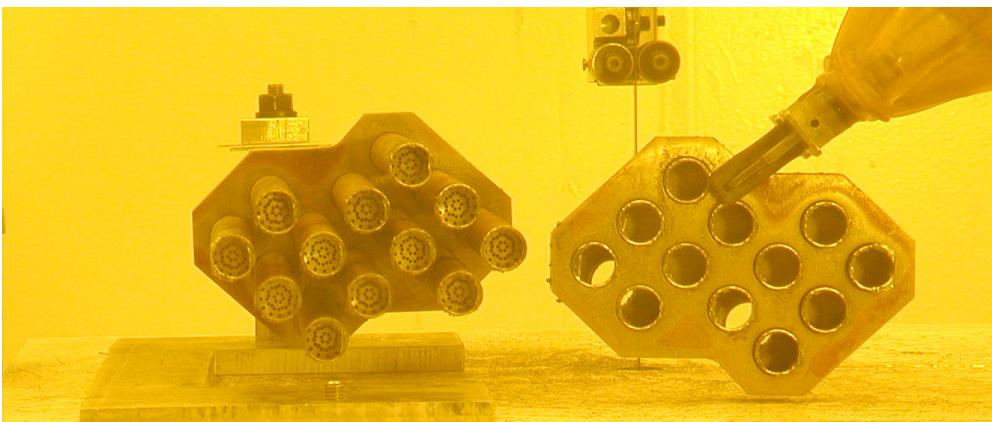
Removal of Tungsten Neutron Source After Irradiation

- Clad Tungsten Source cut from Insert and transported to CMR Hot Cells
- Bandsaw in hot cells used to cut manifolds from tubes
- Helium leak test performed in hot cells showed clad rods still leak tight after irradiation.
- Discoloration on outside surface due to high nitric acid irradiation environment.
