MICE: overview

Muon Ionisation Cooling Experiment

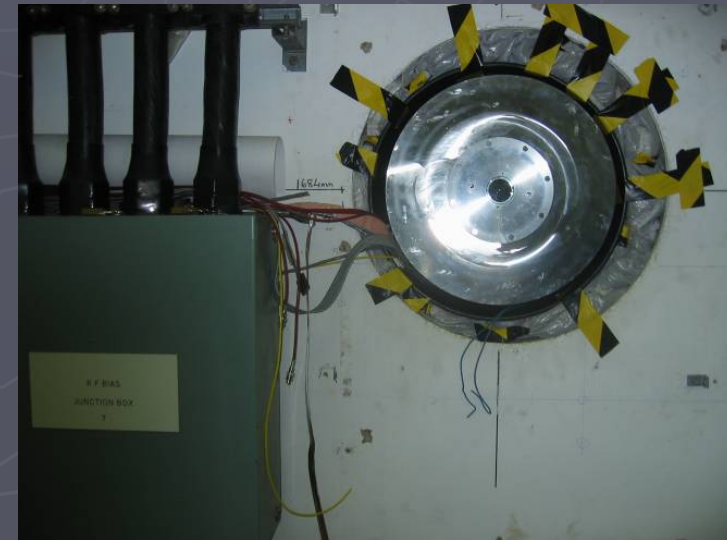
Upstream beam line:

- ▶ Q1—Q3 and D1 installed, all services connected
 - Issues:
 - ▶ Q1, Q2 power supplies damaged by water leak
 - Have been returned to Dan Fysik for repair
 - ▶ D1 power supply 'blew' resistors in smoothing circuit
 - Spares to arrive from Dan Fysik today
 - Re-install and check source of problem ...and correct
- ▶ Solenoid in position and packed with shielding

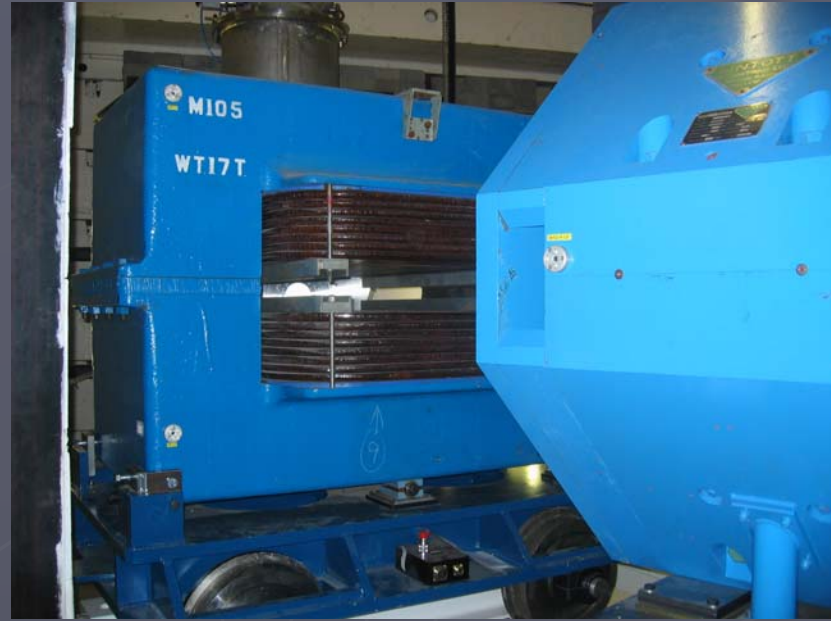
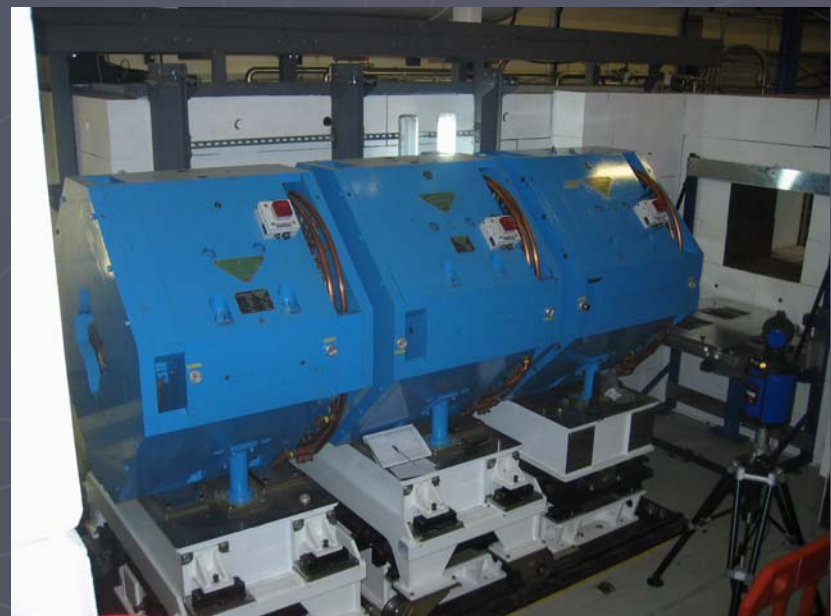
Beam line in DSA:

- ▶ D2 and Q4—Q6 installed and services connected
- ▶ Issues:
 - D2 on temporary water:
 - ▶ Piping now in place
 - Q4—Q6:
 - ▶ Water flow rate needs to be increased

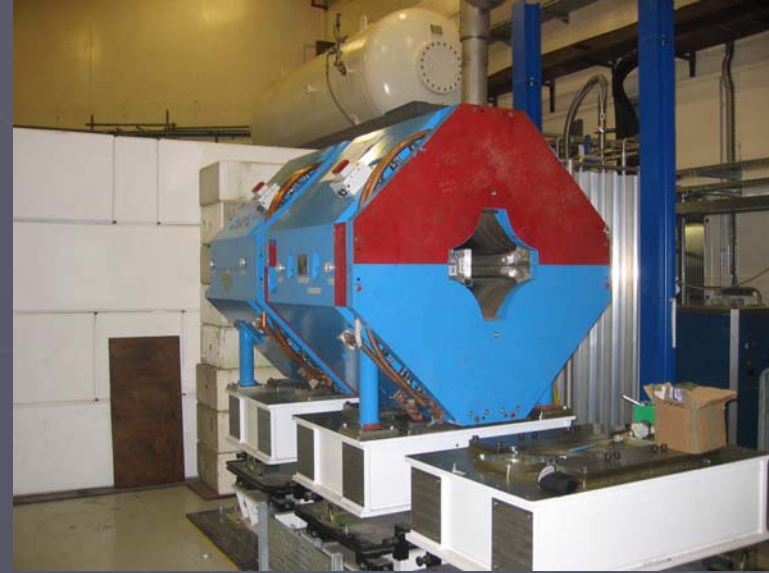
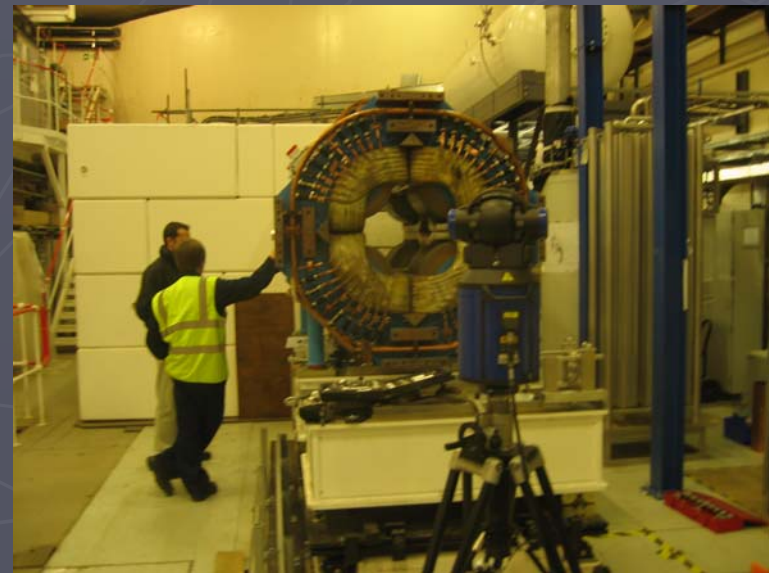
Downstream beam line

- ▶ Q7 and Q8 installed and aligned
- ▶ Q9 to be installed this week:
 - Issue: water manifold weeps, braze to be effected in MICE Hall
- ▶ Water and electrical services to be connected in present shutdown

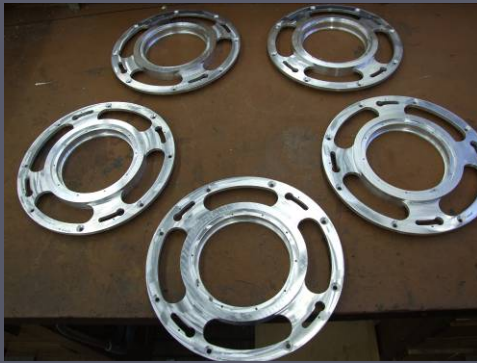
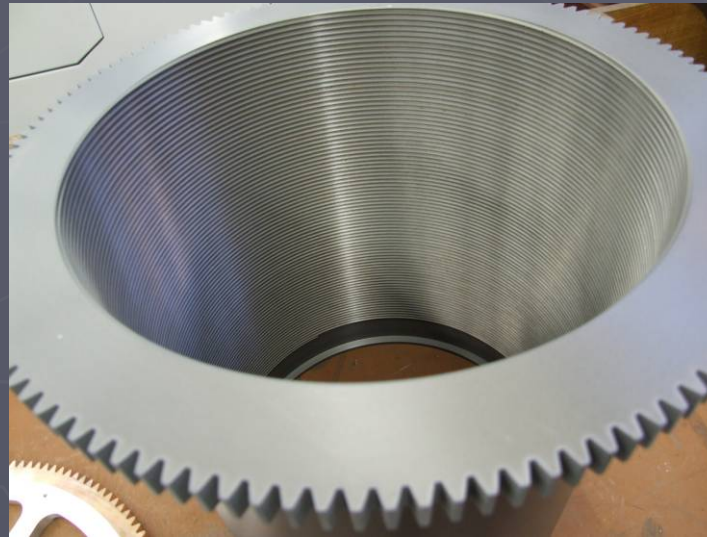
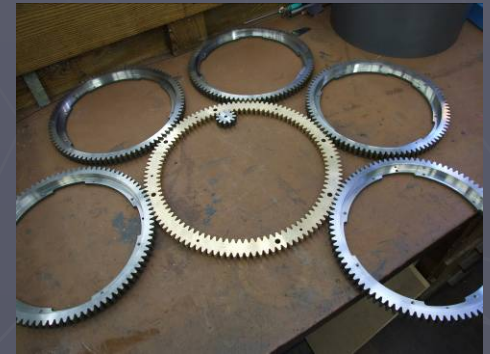
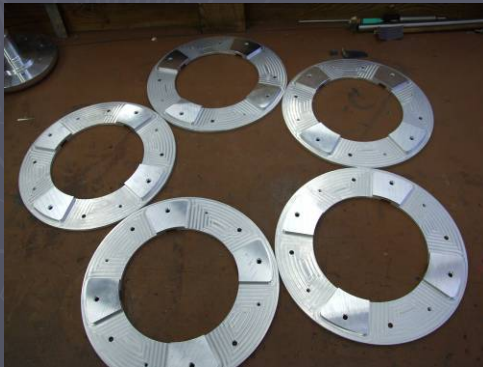
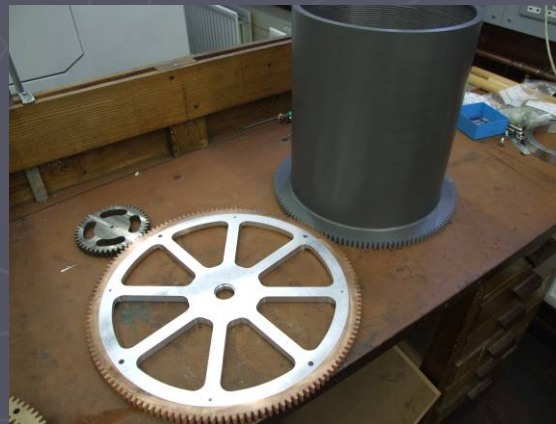
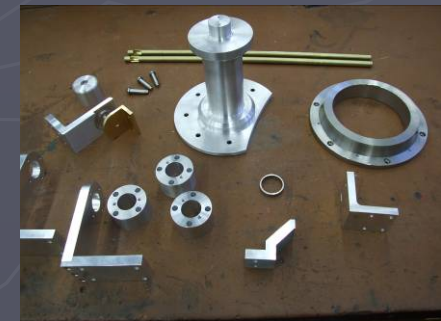
MICE Diffuser (Oxford)

Parts cutting goes on (~60% completed)
Stand is designed
